2880 South Locust Street Garage: Rehabilitation Feasibility Report

March 10, 2026

Martin/Martin, Inc. Project Number: 26.0018.S.01

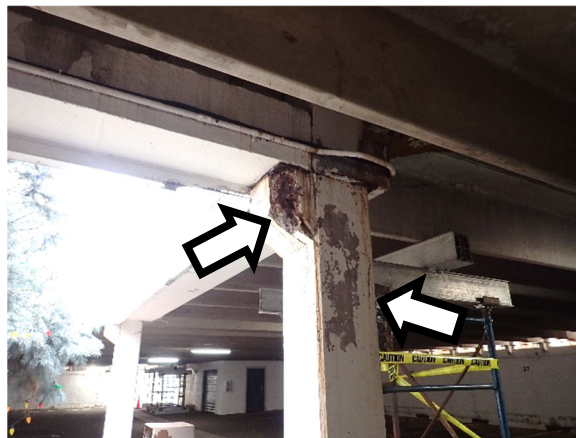
The existing parking garage structure is in poor condition. Significant concrete member reconstruction and some concrete member replacements are required to return the structure to a baseline condition. Two columns are in poor condition and should be replaced (Photo 1). We suspect that if repair of these elements is attempted, hidden damage will be discovered during construction which will necessitate total replacement. Several wall panels have bubbled paint and staining which suggests that the concrete section has been saturated with chloride-laden snow melt for decades and that the embedded reinforcing steel is likely damaged beyond repair (Photo 2). These wall panels are identified for replacement in the Repair Cost Table. Other concrete walls are deteriorated and require repairs, some will be partial-depth repair only, and others will include full-thickness replacement over a portion of the wall.

Photo 1 – Deteriorated Column

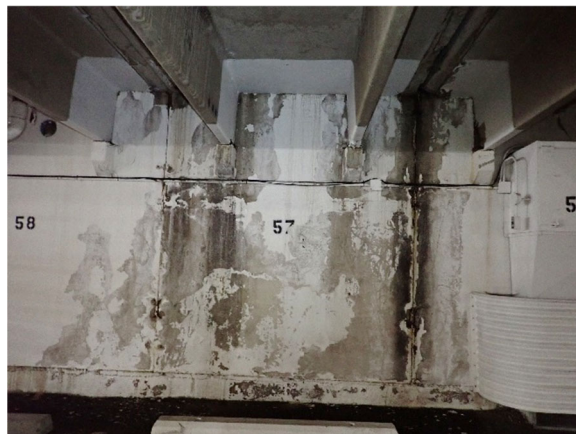
Photo 2 – Deteriorated Precast Wall Panel

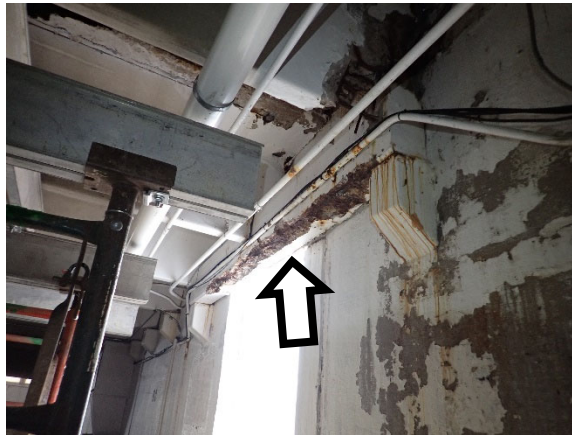
Some concrete beams are deteriorated and require repair or replacement dependent on the extent of damage uncovered during construction (Photo 3). We have used our experience with similar projects in the Colorado region to anticipate which beams can be repaired, and which need to be replaced below in the Repair Cost Table. Precast concrete double-tees are in poor condition and repairs are required to flanges and bearing zones, and in some cases external strengthening is required to supplement deterioration around the support (Photo 4). Various concrete repairs are required at the upper-level parking surface before new waterproofing systems can be installed.

Photo 3 – Deteriorated Concrete Beam

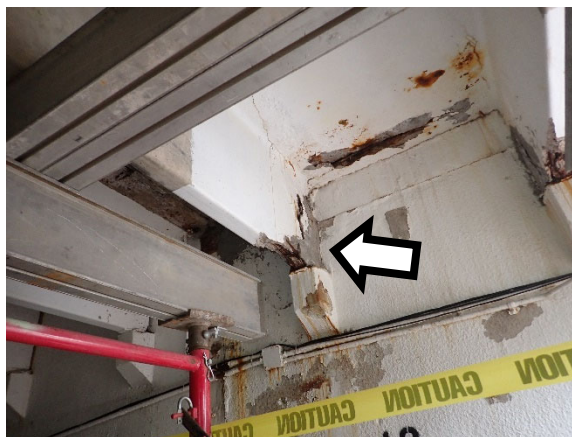
Photo 4 – Deteriorated Precast Double-Tee

The structural repairs should be completed first, then waterproofing system improvements should be implemented immediately after to protect the integrity of the repairs. Waterproofing system repairs include replacing joint sealants and installation of elastomeric surface-applied coatings rated for vehicle traffic. These products will require scheduled maintenance on an annual basis to maintain the integrity of the waterproofing system and full replacement will be necessary 10 to 12 years from installation date.
